NASA TN D-2040

A STUDY OF SEVERAL  
OXIDATION-RESISTANT COATINGS  
ON Mo-0.5Ti ALLOY SHEET AT 2,500° F

by Donald R. Rummler, Bland A. Stein,  
and Richard A. Pride

Langley Research Center  
Langley Station, Hampton, Va.

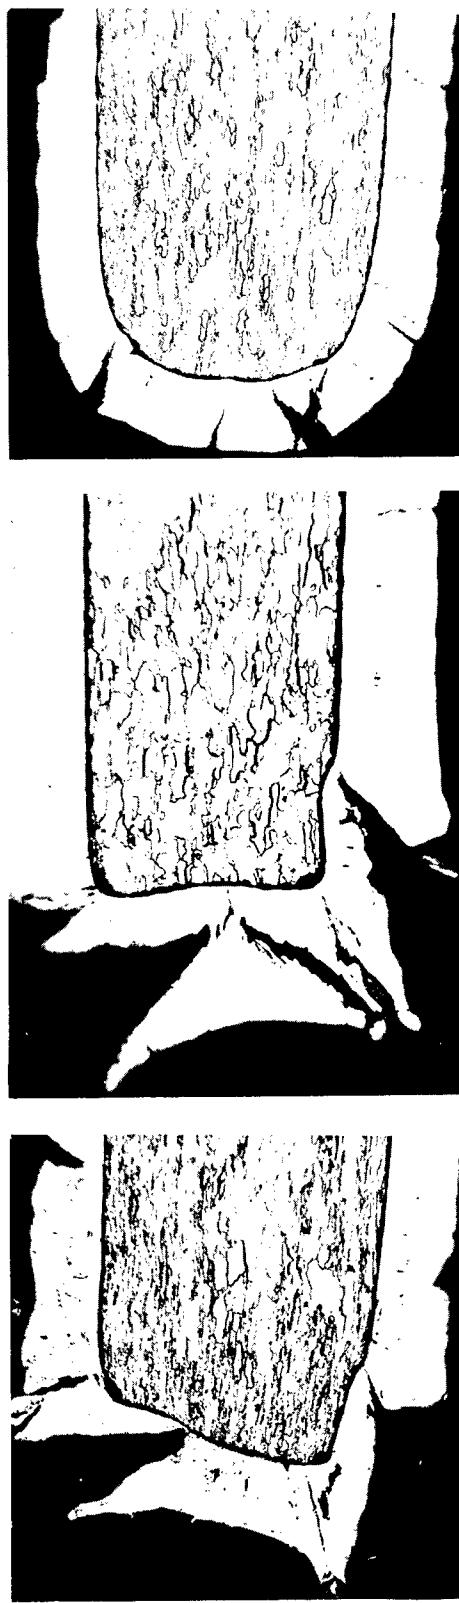
Edge preparation is generally considered an important factor in coating performance on sheet material. Photomicrographs (fig. 10) of one of the coatings before exposure are typical of the as-coated appearance for the three edge conditions under investigation. As expected, the coating on the tumbled edge appears superior to the other two. The partially recrystallized substrate of the tumbled-edge and the sheared-edge specimens would suggest that these two edge preparations are less severe than the broken-edge preparation which resulted in a fully recrystallized substrate. The lower recrystallization temperature of the broken-edge specimen, which may be the result of a more severe fabrication process and the accompanying higher residual stresses, could contribute to a shorter life for a coating applied to this edge condition.

The rounded edge of the tumbled-edge specimens, in addition to the lower residual stresses inherent with the tumbling operation, resulted in an even coating thickness and less severe radial cracking (fig. 10). This uniformity of coating thickness on the edges would be expected to produce a coating which is more reliable and less prone to edge failures.

(a) Sheared edge.  
(b) Broken edge.  
(c) Tumbled edge. L-63-4796  
Figure 10.- Appearance of a typical coating after application on 0.012-inch Mo and -0.5Ti sheet specimens with three edge conditions. Approximately X150.

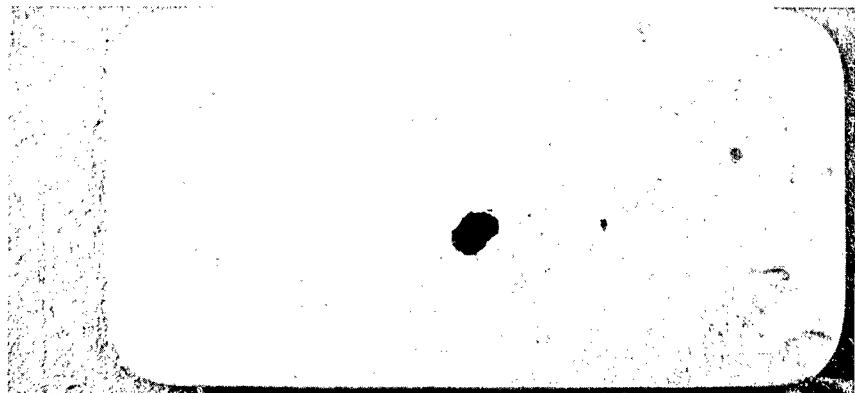
Figure 14.- Coating A(G) tumbled-edge oxidation specimen after 976.2 hours of continuous exposure at 2,500° F in air.

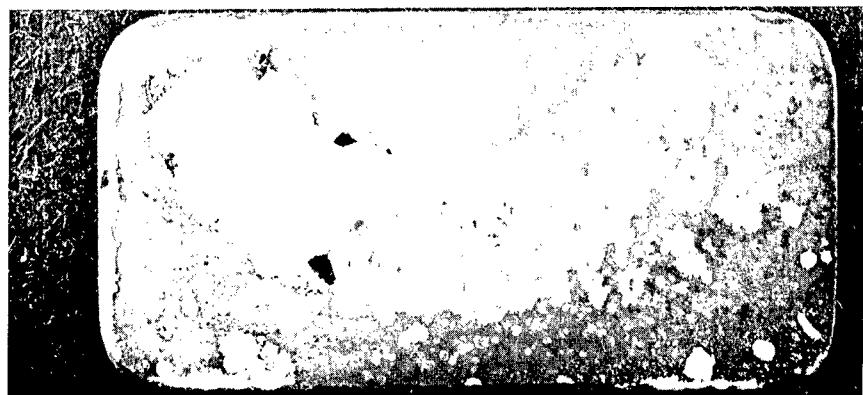
Figure 17.- Coating D tumbled-edge oxidation specimen after 18.4 hours of continuous exposure at 2,500° F in air.

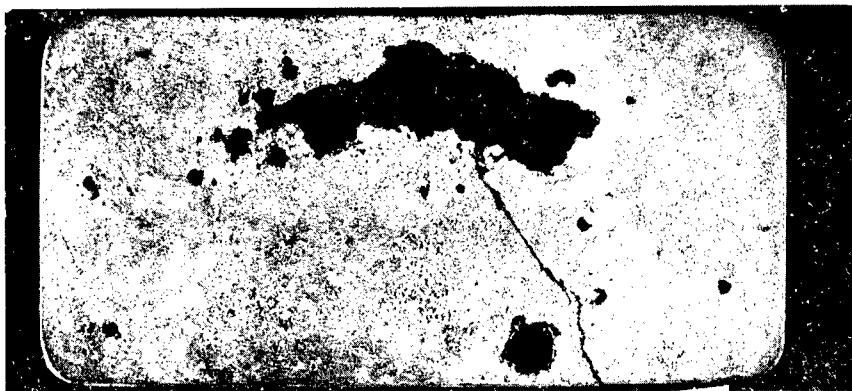
All three specimens with coating E which were tested in the broken-edge condition failed within 15 minutes after exposure at 2,500° F in air. There was no apparent reason for this early failure. These specimens had received the same coating procedure as the other coating E specimens, and metallographically examined broken-edge specimens revealed no insight to the poor performance of this coating on the broken-edge specimens. The fact that all three specimens exhibited a general breakdown of the coating (table IV) would indicate that the coating procedures for these specimens were at fault and not the additional edge treatment these specimens received. The information presented in table IV for the broken-edge specimens is similar to the information presented in table III for the sheared-edge specimens.

Figure 18.- Coating E broken-edge oxidation specimen after 0.1 hour of continuous exposure at 2,500° F in air.

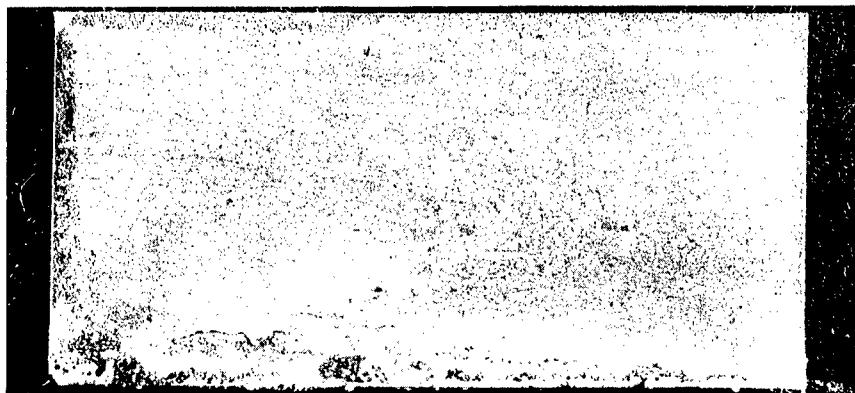
Figure 19.- Coating C broken-edge oxidation specimen after 5.0 hours of continuous exposure at 2,500° F in air.

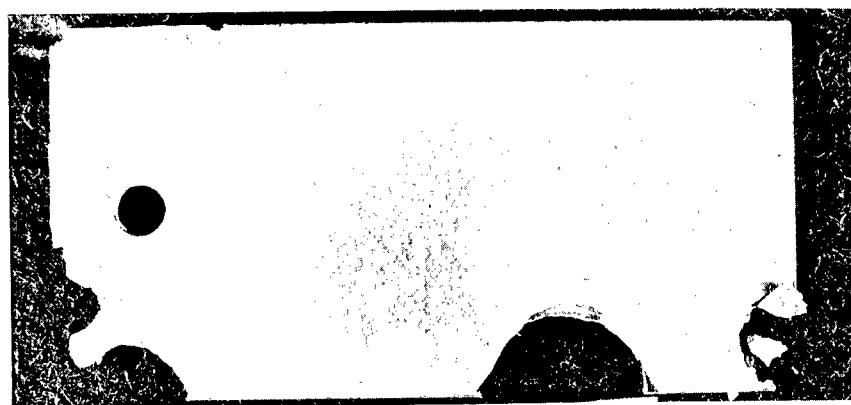
Figure 20.- Coating B broken-edge oxidation specimen after 20.7 hours of continuous exposure at 2,500° F in air.

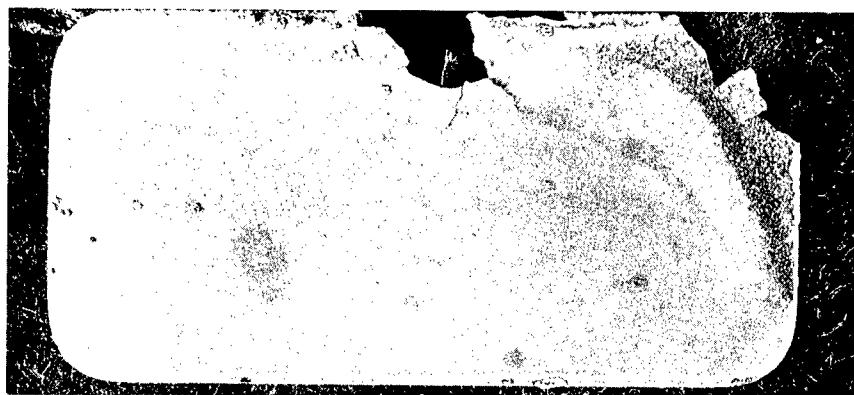
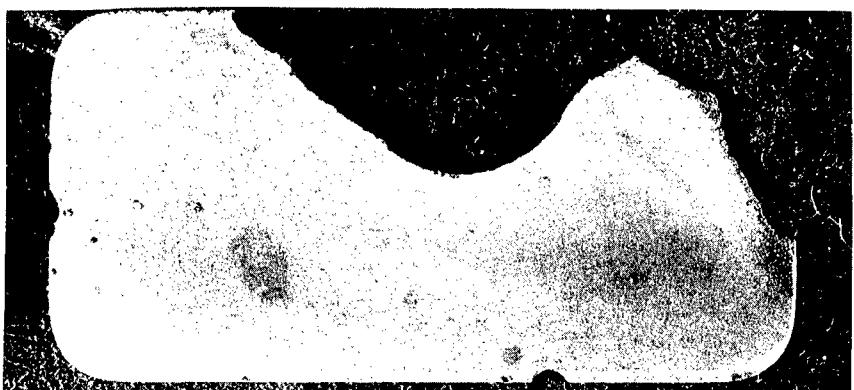
The cyclic tests provided a good opportunity to observe the initiation of failure, and as previously mentioned, visual examination was an unreliable method of detection. After each cycle the specimens were inspected, and in some cases a weight loss of 3 percent did not produce a visible defect in the coating. When a visible defect was found, the specimen was probed to reveal the full extent of substrate damage. Some typical examples of these initial defect points are presented in figures 26(a), 27(a), and 28(a). Figures 26(b), 27(b), and 28(b) present these same specimens after failure. In figure 28 the final failure appears to be only an extension of the original defect. The continued oxidation of the initial defect to produce a 10-percent weight loss was not the only mode of failure. In most of the cycled specimens, other points of failure on the edges were initiated before a 10-percent weight loss terminated the test (figs. 26 and 27). These additional edge failures indicated that the edges of the cycled specimens were marginally protected by the coating when the specimens were subjected to thermal cycling. When the test was terminated, the full extent of substrate damage was not apparent until after the specimens were probed to remove unsound material. Figures 29, 30, and 31 show typical failed specimens before and after probing.

Figure 30.- Coating C tumbled-edge oxidation specimen after three 1.0-hour cycles at 2,500° F in air.
